NBSIR 75-645 (R)

Study of the Initial Stages of Wear by Electron Channeling Microscopy

Metallurgy Division
Institute for Materials Research
National Bureau of Standards
Washington, D. C. 20234

Interim Report for Period 1 May 1974 through 31 December 1974

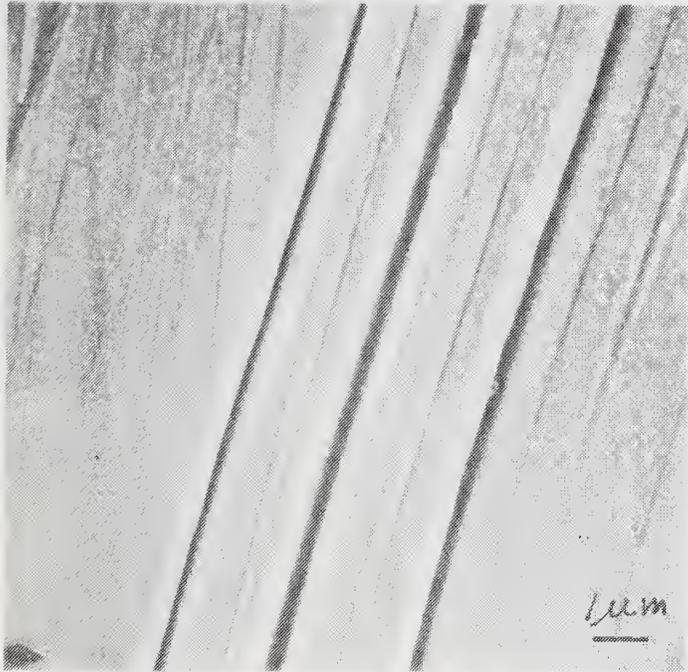
Fig. 3. (a) Cluster of scratches on iron single crystal surface due to steel cutting edge. (b) Scratches on iron surface from $1 \mu\text{m}$ alumina particle abrasion.

The crystal surface was next lightly scratched in one area with a steel point. That area is shown in Fig. 3a. A typical cutting wear track was formed with considerable material displacement produced into lips adjacent to the track center. Large plastic strains would be involved in such deformation and large residual strains would be expected [9,10]. SACP's taken from the area of the scratches showed considerable pattern broadening associated with large residual strains. SACP's obtained from areas adjacent to the cutting scratches showed little evidence of broadening.

A second experiment was conducted on this crystal surface involving three sliding wear strokes taken under light ($\approx 25\text{g}$) load, oil lubricated, with abrasive alumina particles about $1\ \mu\text{m}$ diameter present. Figure 3b shows some details associated with these wear tracks. The deeper tracks extending across the field of view appear to involve small lips of material much like the larger cutting scratches above. Many of the alumina induced scratches end within this field by becoming increasingly shallow and narrow as though the load carried by the particle involved was decreasing to zero. This may indicate that the clearance between the bearing pin and surface increased locally due to surface flatness variations which could easily exceed $1\ \mu\text{m}$ ($40\ \mu\text{-in}$) peak-to-peak in this sample.

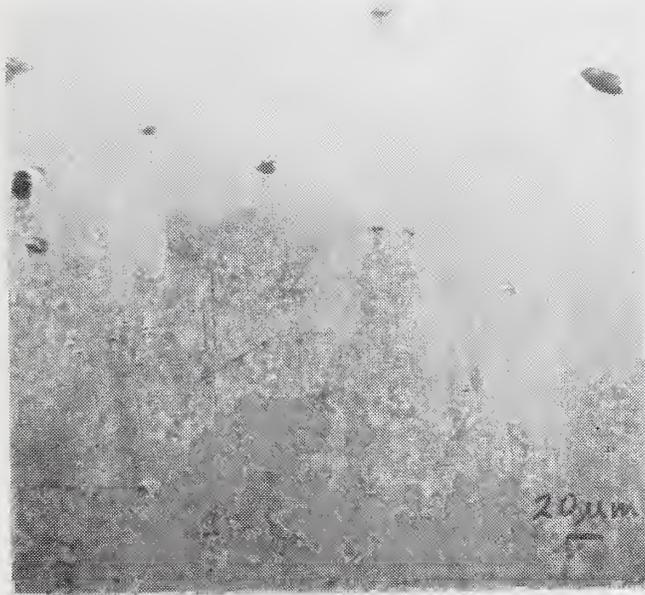
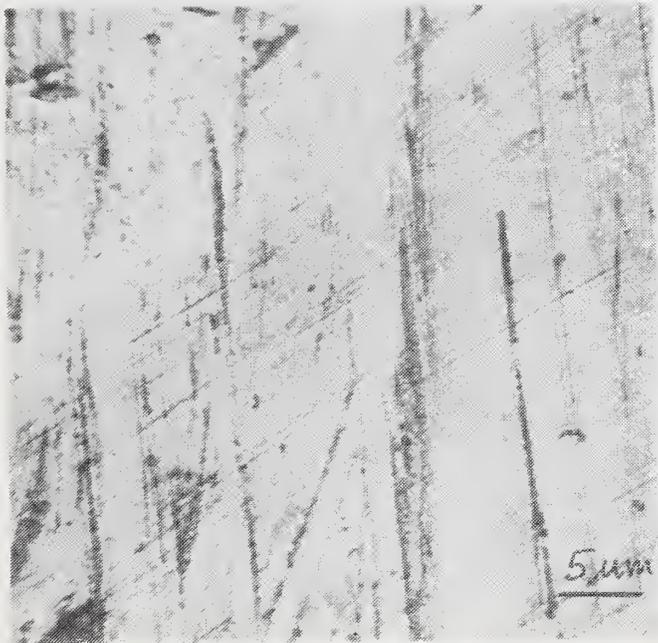
Fig. 9. (a) Worn region on 52100 steel bearing ball after 700 cycle wear test on iron sheet specimen. (b) Detail of worn region.

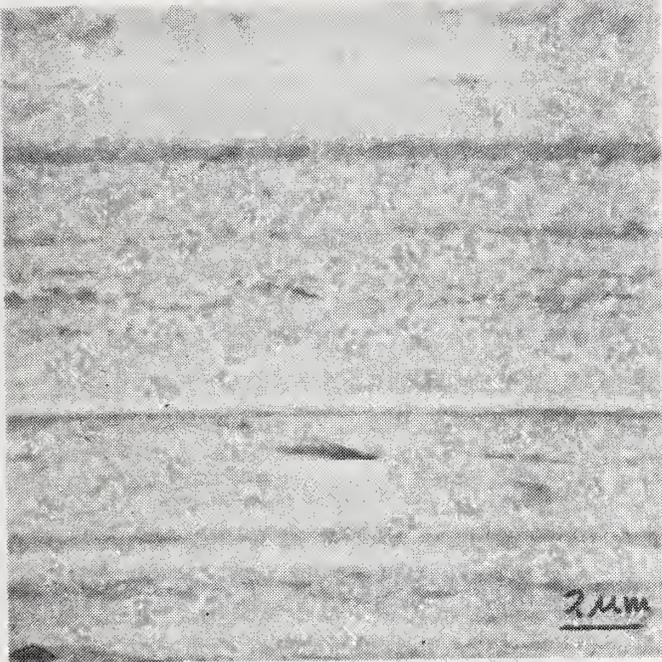
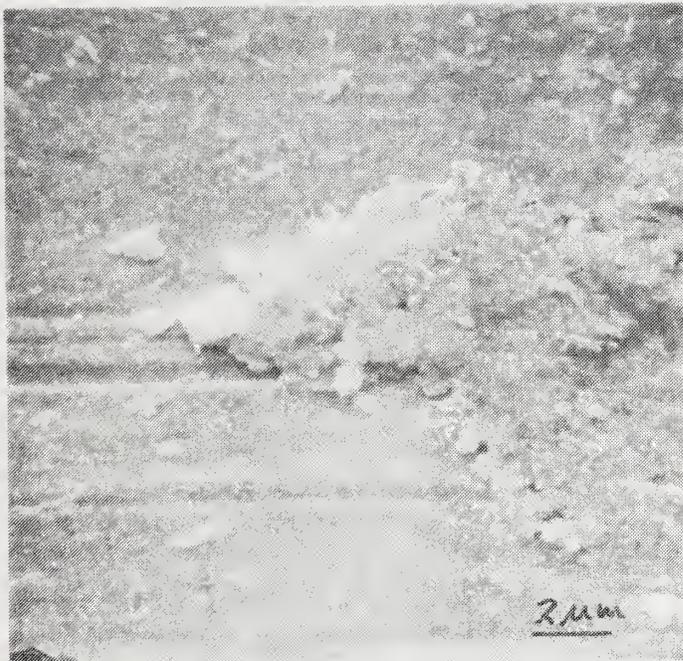
Fig. 11. (a) Central region of wear track showing small unworn areas surrounded by deformed areas. (b) End of slider wear track showing displaced material (oxides?) and wear debris.

Several areas from the wear track on the electropolished iron sheet surface are shown in Figs. 10 and 11. Details typically found at the edge of the wear track are seen in Fig. 10b. Material is plastically deformed under the slider contact, moved to the edge of that contact and presumably breaks free to contribute to the wear debris. The unworn electropolished surface is shown in the lower region of Fig. 10b. The central region of the wear track after 400 cycles (Fig. 11a) still retains areas where contact has been avoided and the electropolished surface structure remains. The end region of the wear track contains a considerable amount of debris and deformed metal as seen in Fig. 11b. Since a substantial oxide film was initially present on this specimen, it seems likely that some of the debris here may be largely iron oxide. Particles whose lateral dimensions are as small as 0.5 μm are seen in this region of the wear track.
